# Performance and Value of the inVision System : Offshore in Coiled Tubing Operations

## Case Study #0004

November 01–21, 2017

Gulf of Mexico,  
Deep Water

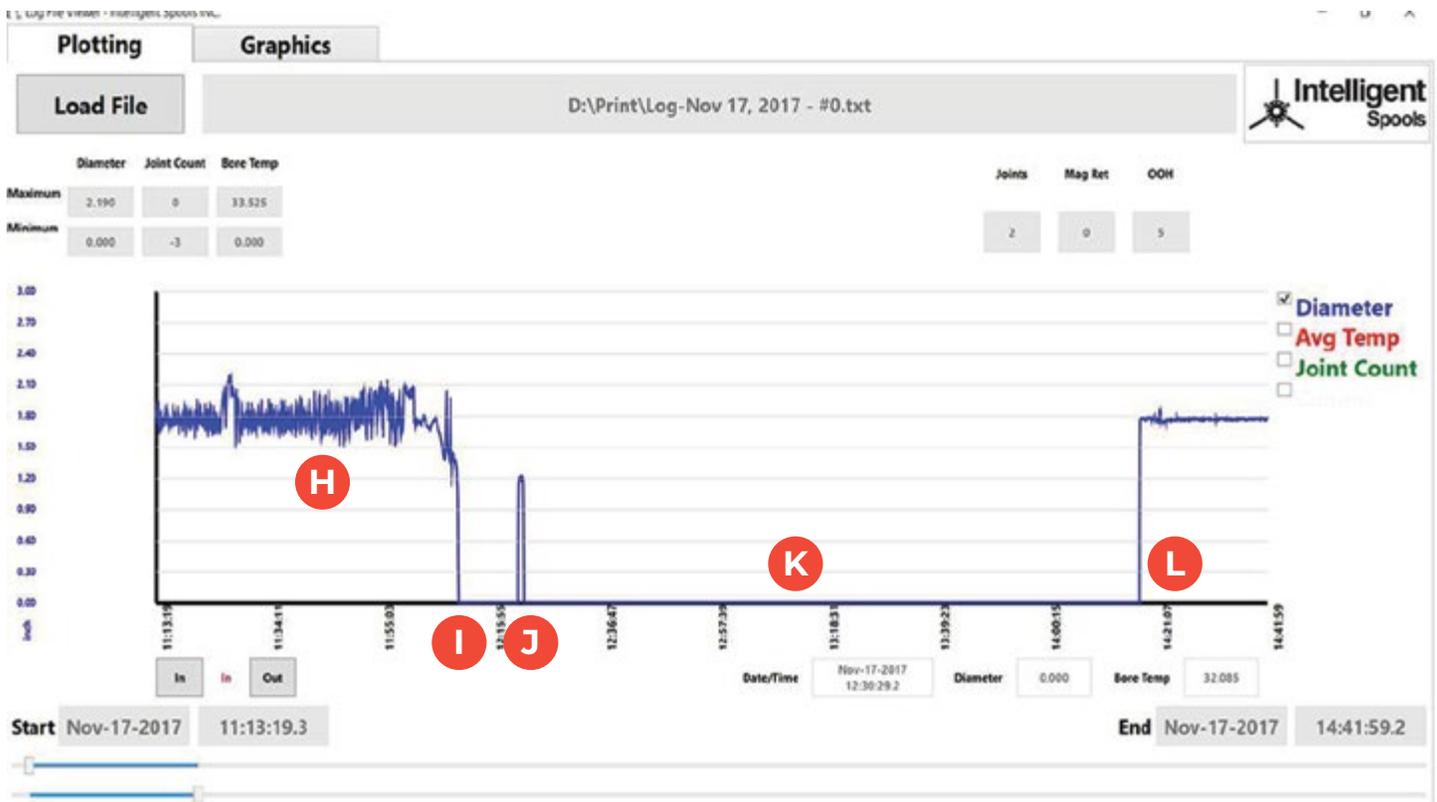
Approximately 2 hours after the realization that the BHA was missing, the crew in the driller's cabin noticed something measuring 1.75" OD at the time stamp of approximately 14:18 (see Figure 5) suddenly appeared on the IWS screen.

The IWS technician was notified and confirmed this information by going through a series of system checks. The checks verified the presence of something with an OD of 1.75" was in fact across the InVision Spool and did appear at the timestamp 14:18. The appropriate BP personnel were notified that the BHA may have been located.

Figure 5. Signature of the trip out of hole (H), signature of the first "Out of Hole" condition (I), signature of the second "In/Out of Hold" condition (J), signature of 2 hour "Out of Hole" data, BHA assumed to be lost (K), signature of 1.75" BHA suddenly appearing (L).

It is believed that at the end of the two-hour window, the pressure on the stripper element either bled off or the friction hold that the stripper had on the BHA let go. This allowed the BHA and coil connector to fall down the lubricator and land on the closed FSV. Due to the placement of the InVision Spool in the stack, the BHA was registering on the system screens while sitting on the FSV.

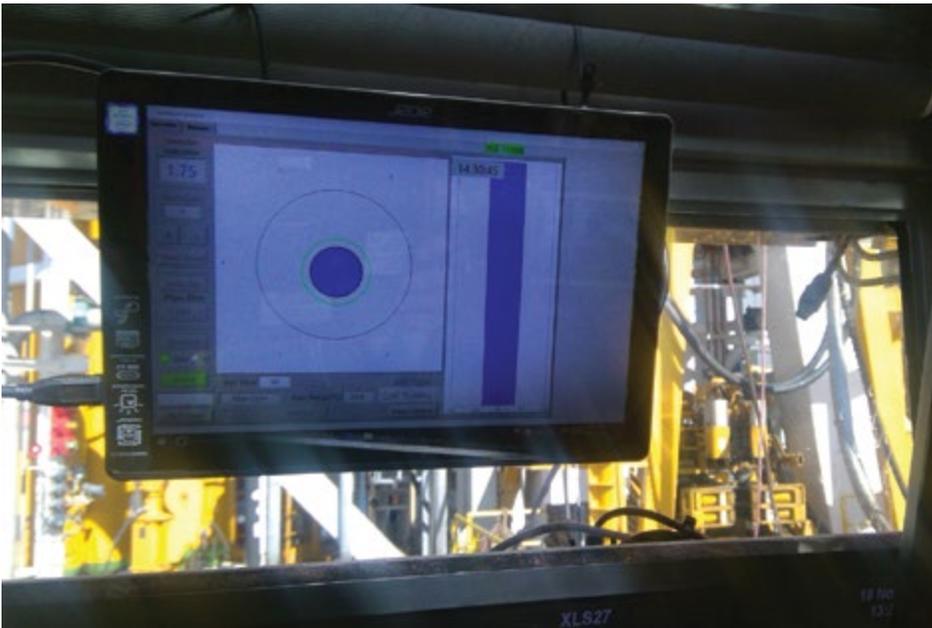
A lead impression block was ran and an imprint of the top of the fish was retrieved. This confirmed without a doubt that the BHA was now sitting on top of the FSV, and that the top of the fish was inside the InVision Spool which was showing the diameter of the BHA of 1.75".

Figure 6. Top of fish sitting inside of the inVision Spool's sensor field

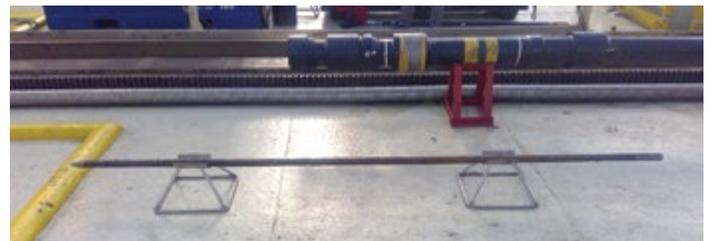
Figure 7. The recovered BHA

Even with all the precautions taken by industry leading operators and service companies in the offshore environment unplanned events happen. Prior to this job, a sample coil connector of same make, model and size was pull tested to 78,000 lbs., to determine failure load. It did not fail. The connector on this job was pull tested as per procedure, staged up from 12k lbs to 25k lbs prior to running in the hole. Bumping up against the stripper to confirm an 'out of hole' condition had worked in the past but did not work this time. The coiled tubing connector released from the string in this situation.

With the fish located, deciding on the forward plan was simplified. Stimulation operations commenced without delay. Planning then commenced for safe BHA retrieval. Once a plan was in place and the stimulation vessel completed its work and was released, the BHA was recovered. The InVision Spool once again showed the end of the BHA pass it and that the bore was clear. A time stamped log of the events was produced at the client's request, to help with the explanation and investigation of this event.
