# Performance and Value of the inVision System : Offshore in Coiled Tubing Operations

## Case Study #0004

November 01–21, 2017

Gulf of Mexico,  
Deep Water

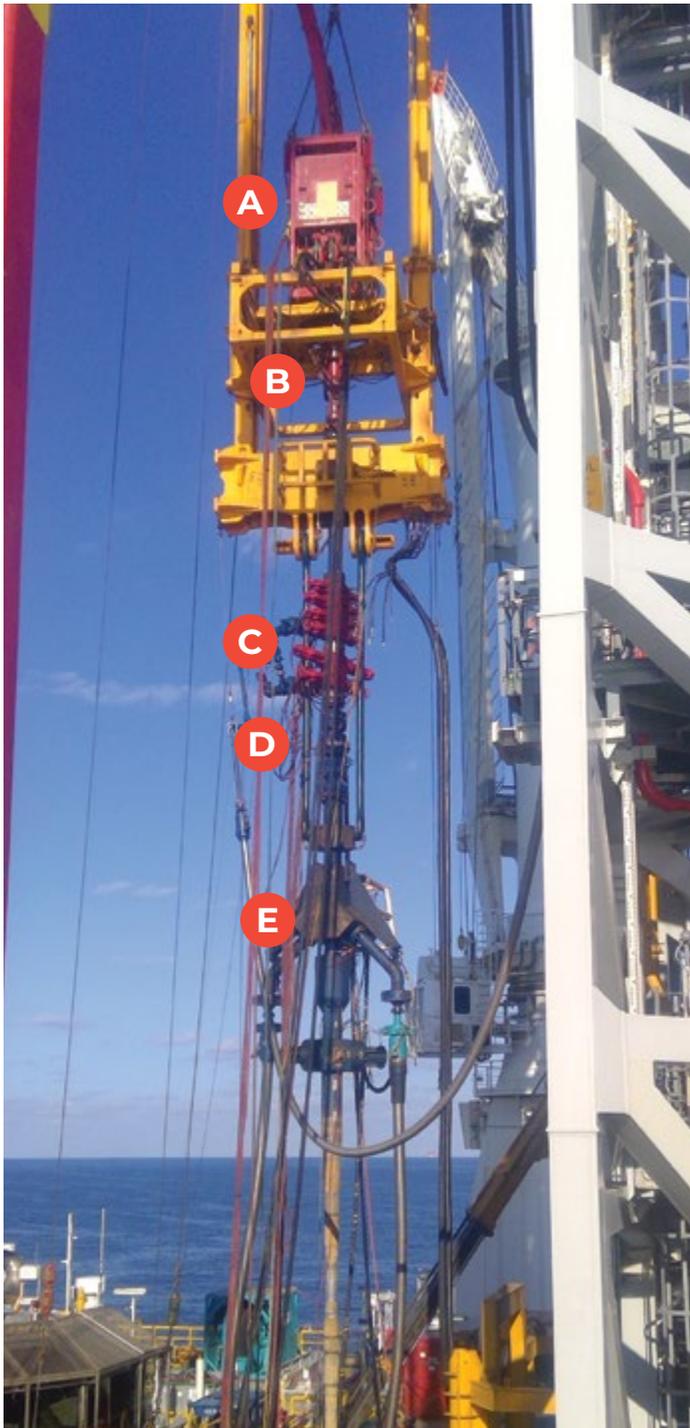
**Figure 1.** Complete Rig Up during coil operations: Coiled Tubing Injector (A), Coiled Tubing Dual Stripper BOP (B), Coiled Tubing BOPs (C), inVision Spool (D), Flow Head Swab Valve(E)

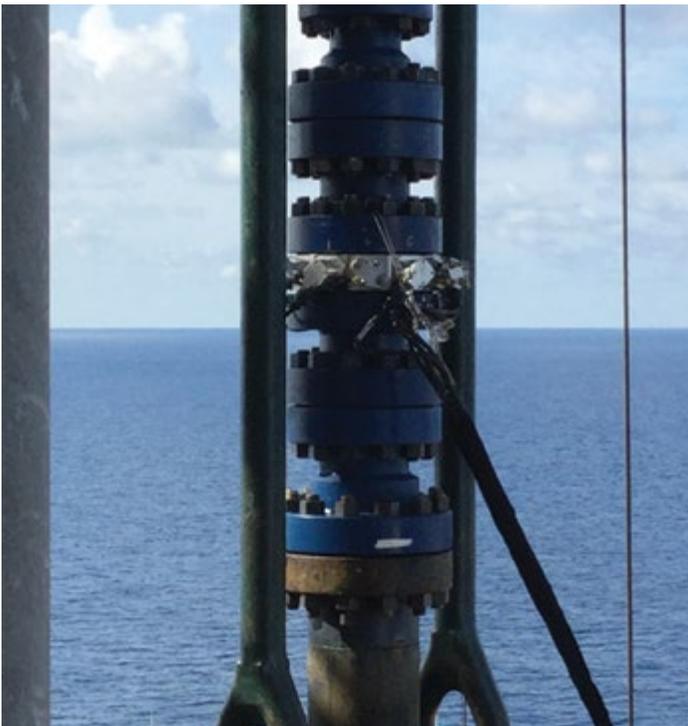
Figure 8. The inVision Spool installed in the stack
